**Pre-Demolition  
McDonald's Restaurant  
3890 South 1100 East  
Salt Lake City, Utah**

IGES Job No. 00115-185

March 12, 2018

**Pre-Demolition Survey  
McDonald's Restaurant  
3890 South 1100 East  
Salt Lake City, Utah**

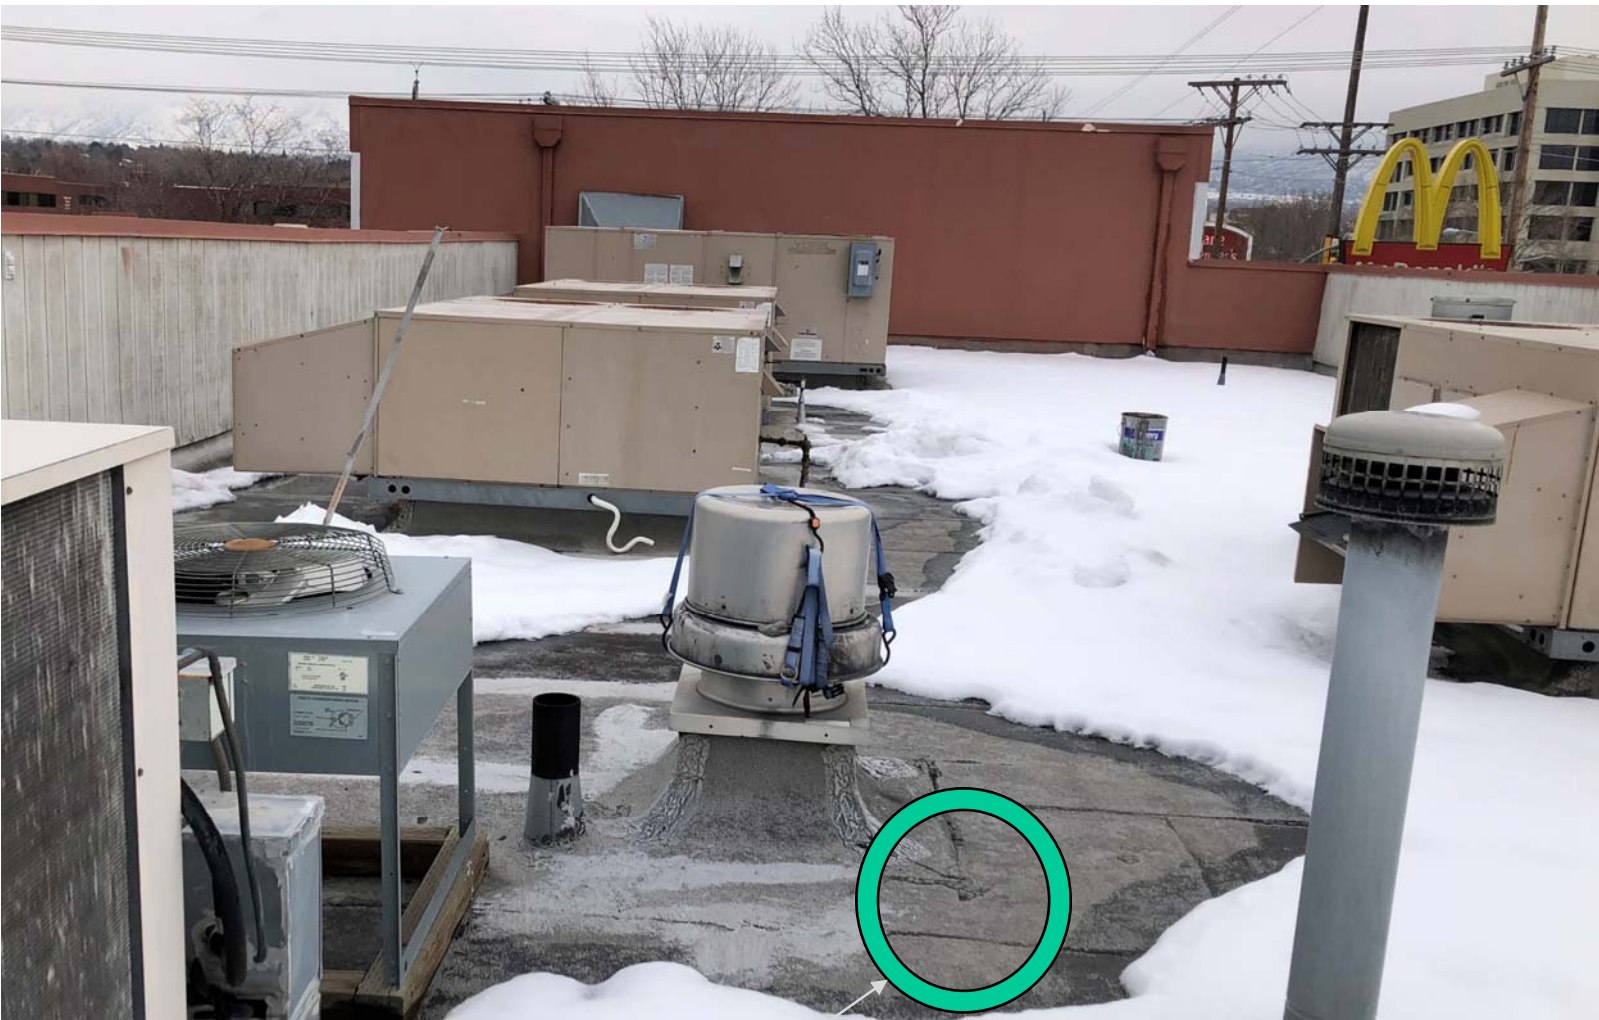
**Figure  
2**

A photograph of the ACM building materials sampled are included in Figure 2. One of five samples of the gray flat roof asphalt shingles contained 15% chrysotile asbestos (#1); the remaining four samples (#2 through #5) were listed as none-detect. The gray flat roof generally consisted of black tar with white rocks and fiberglass backing. The roof tar was generally homogenous and black but, in some areas, it was covered with a silver colored sealant.

**Black  
Asphalt  
Sealant  
(typical)**

Provided the gray flat roof and roof tar is not subject to sanding, grinding, cutting, abrading, burning, etc. in a manner that will result in the material becoming friable or pulverized into powder, it can remain during renovation and demolition. If these building materials are left in place during renovation and demolition, all OSHA regulations should be followed to protect workers and other occupants of the site while renovation and demolition are taking place.

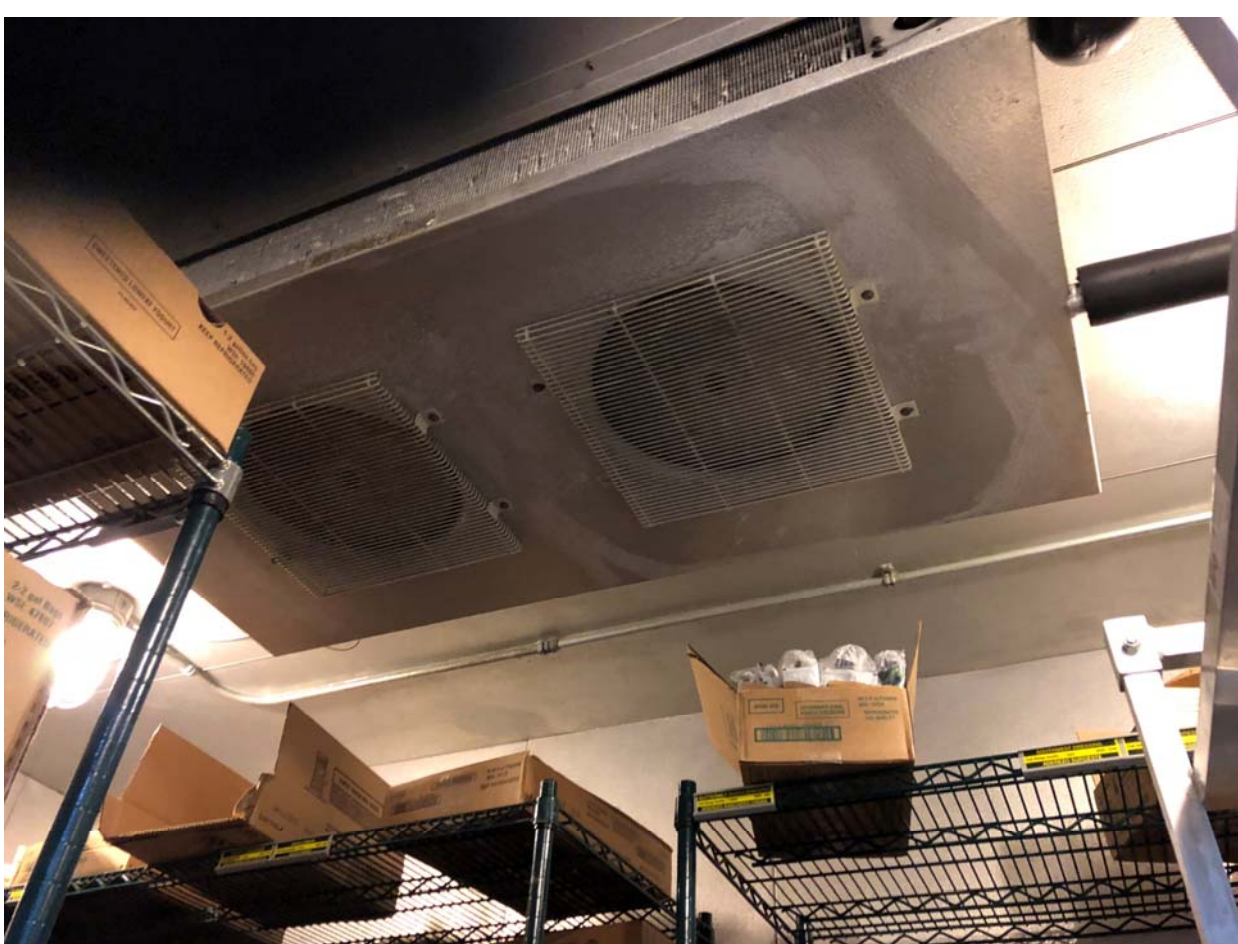
**Walk-in Cooler**

Any CFCs identified in the roof-top units, walk-in coolers and freezers and drink refrigeration units should be completely removed by an EPA-certified technician prior to demolition of the building.

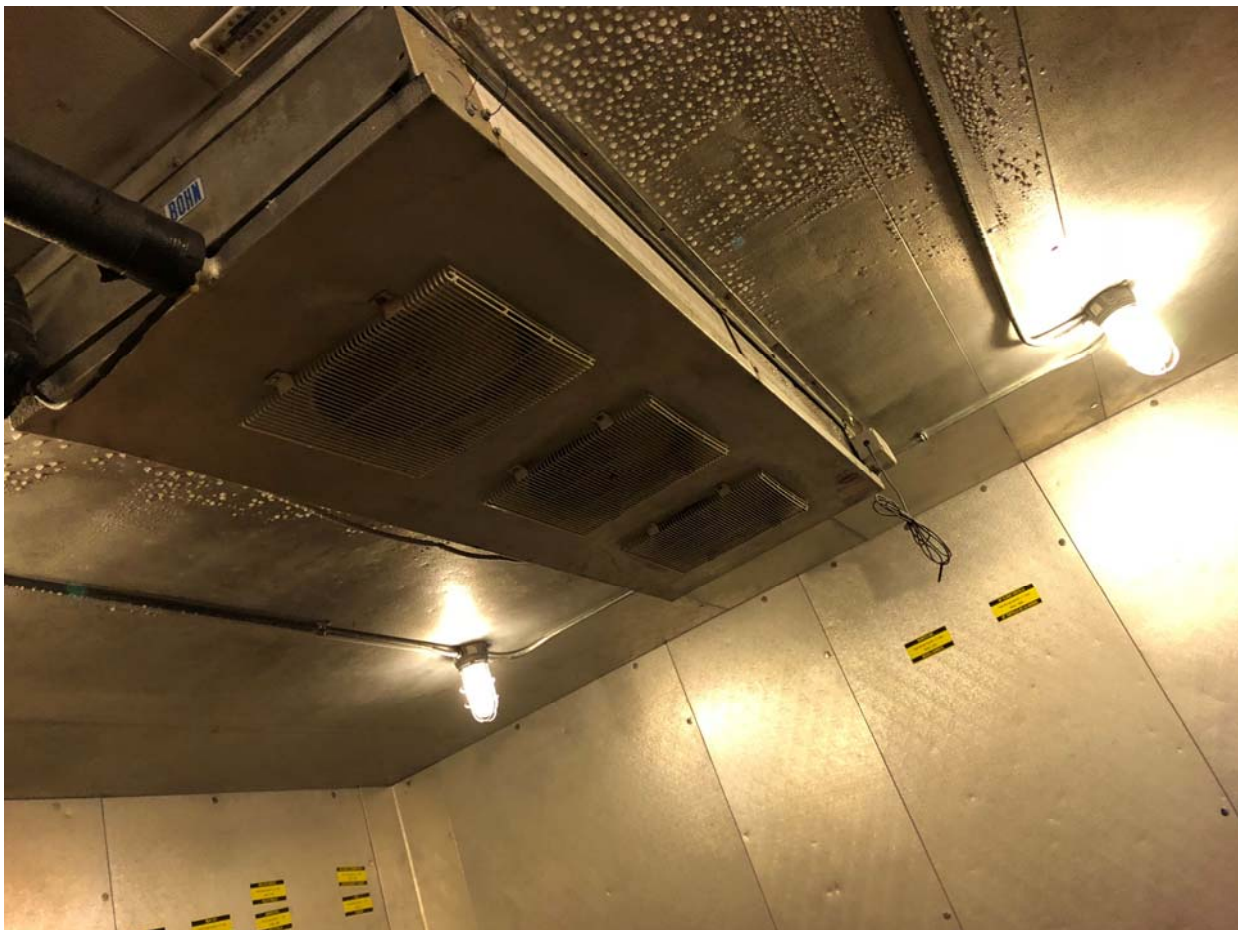
**Walk-in Freezer**

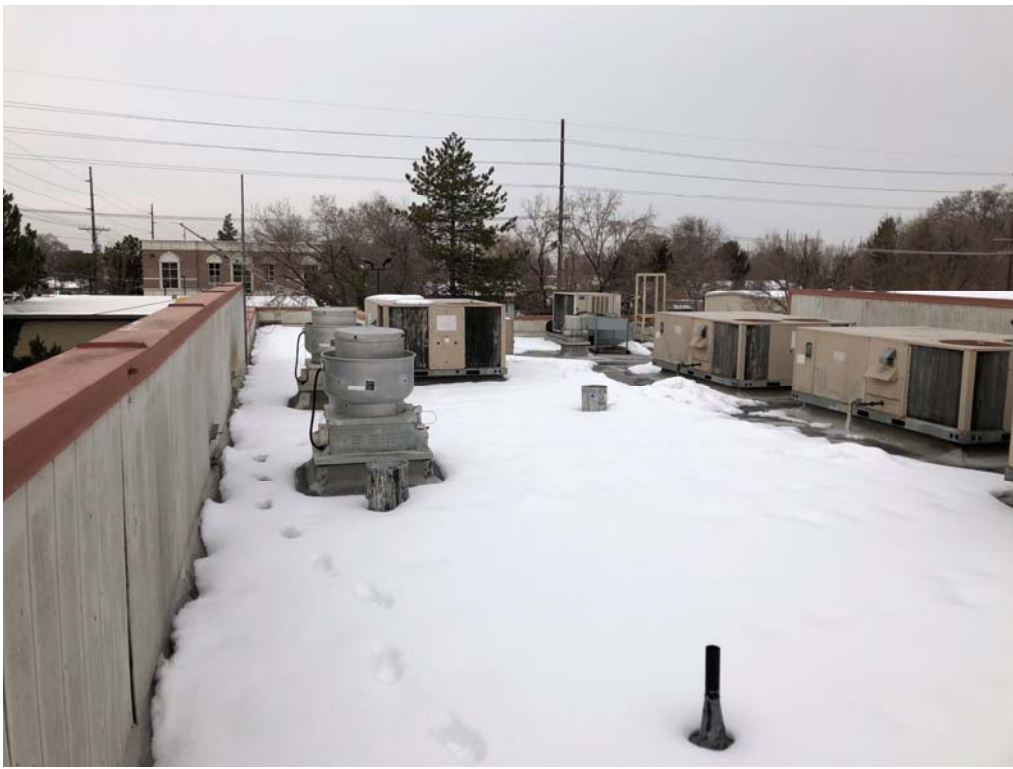
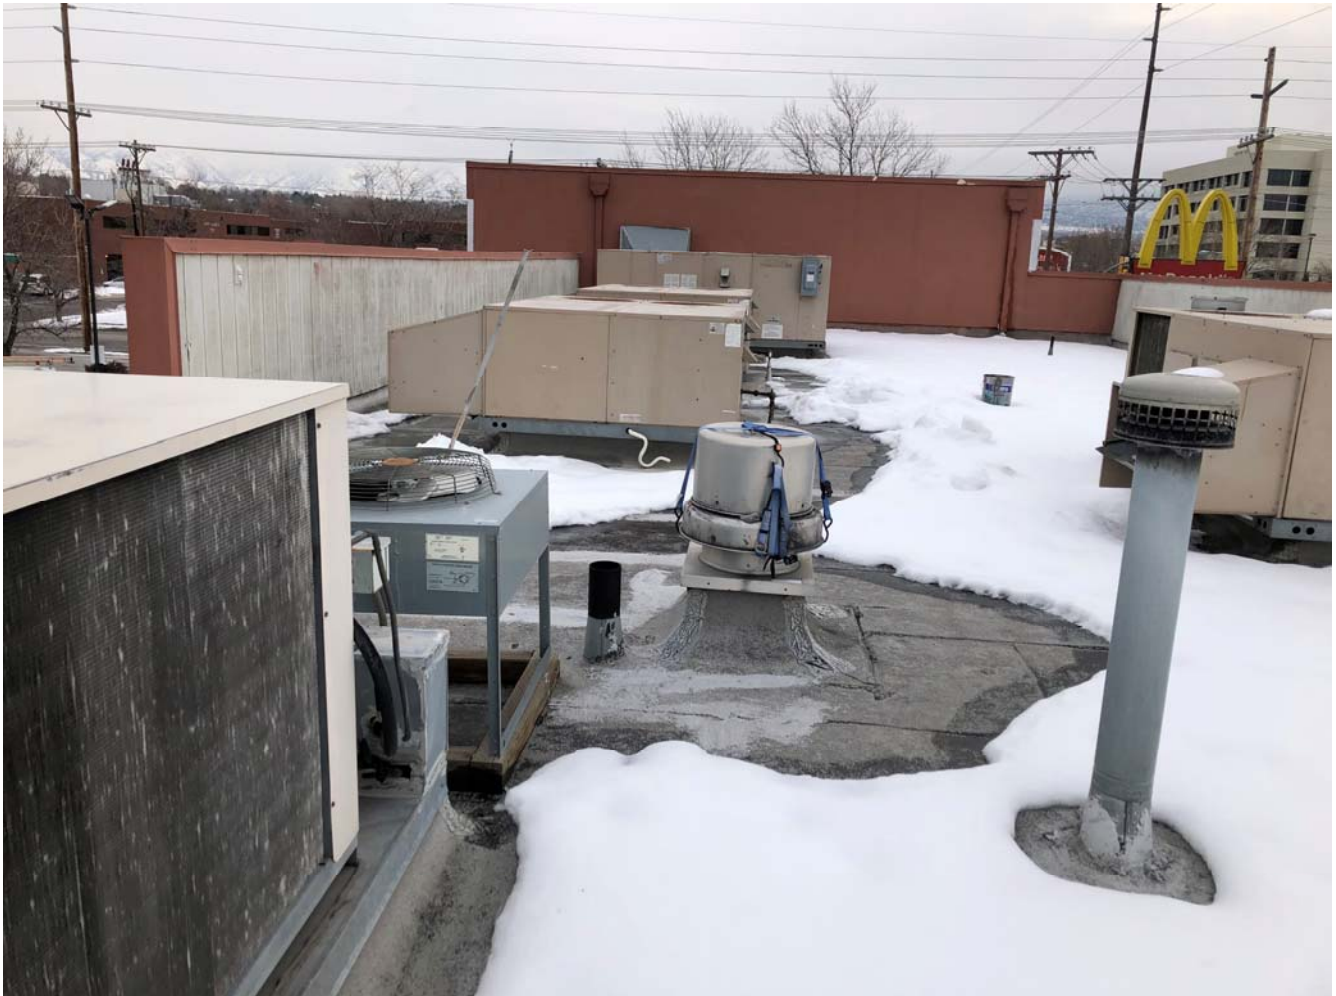
**Roof-top units**

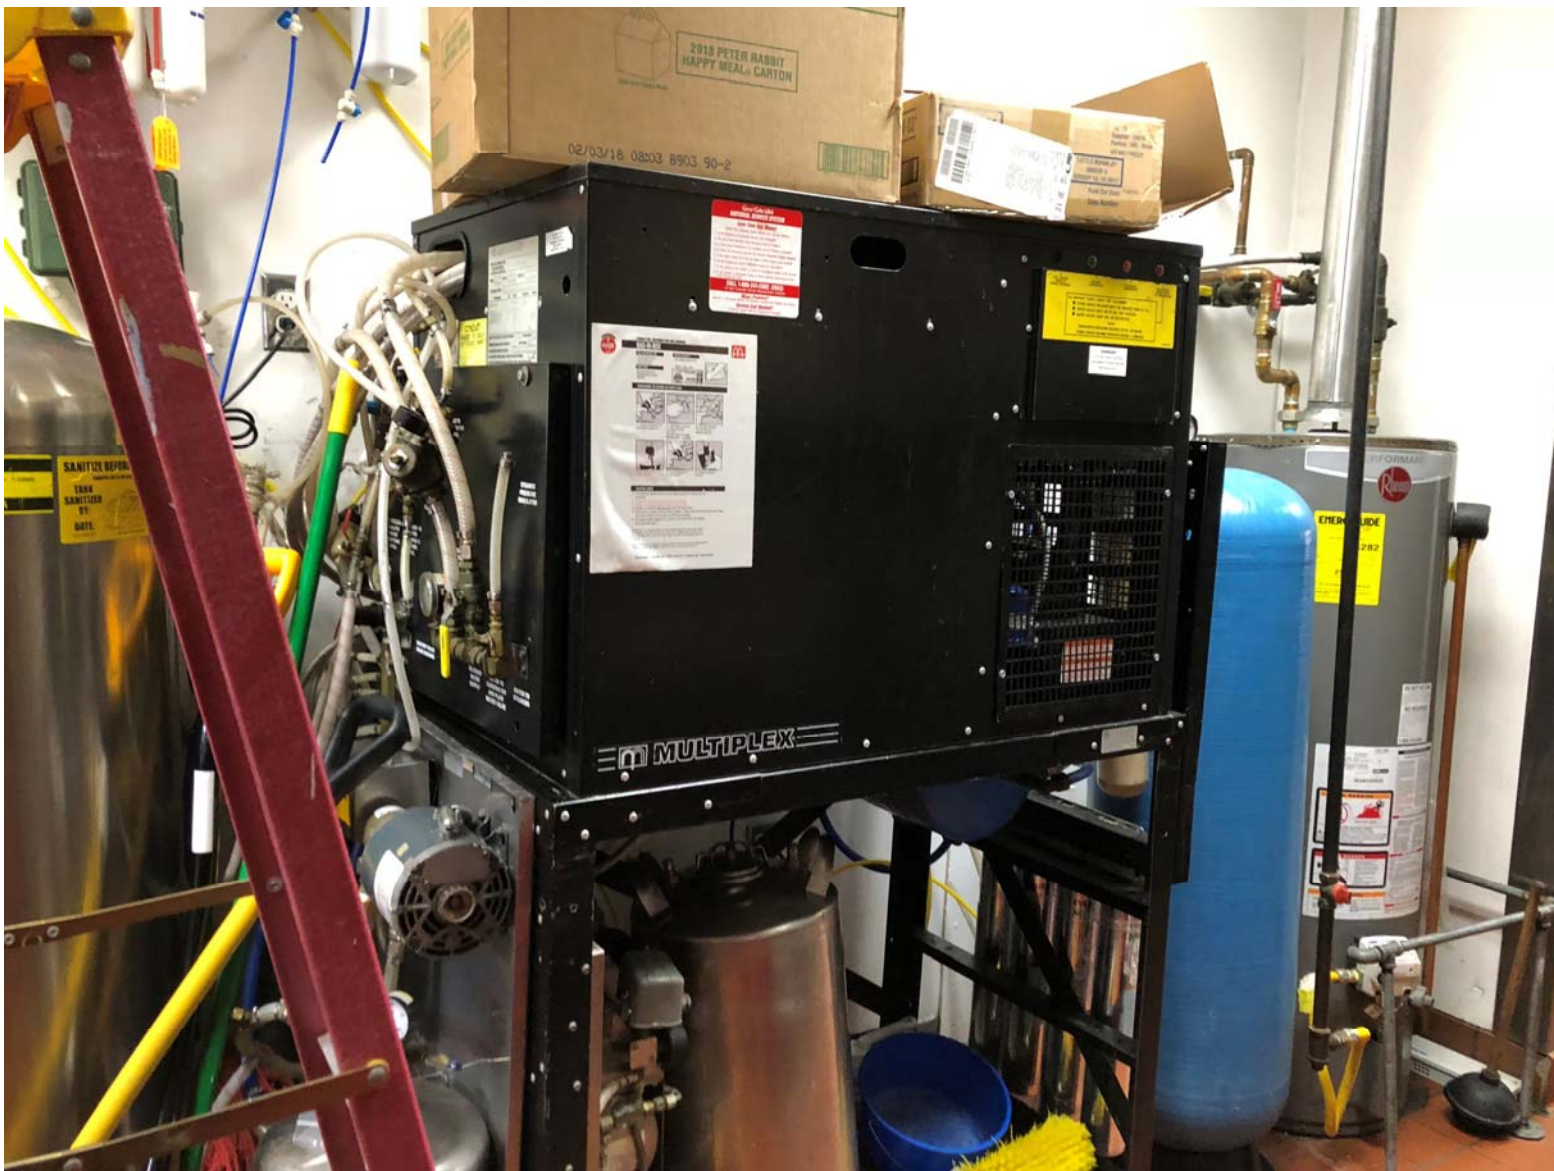
**Drink Chiller**

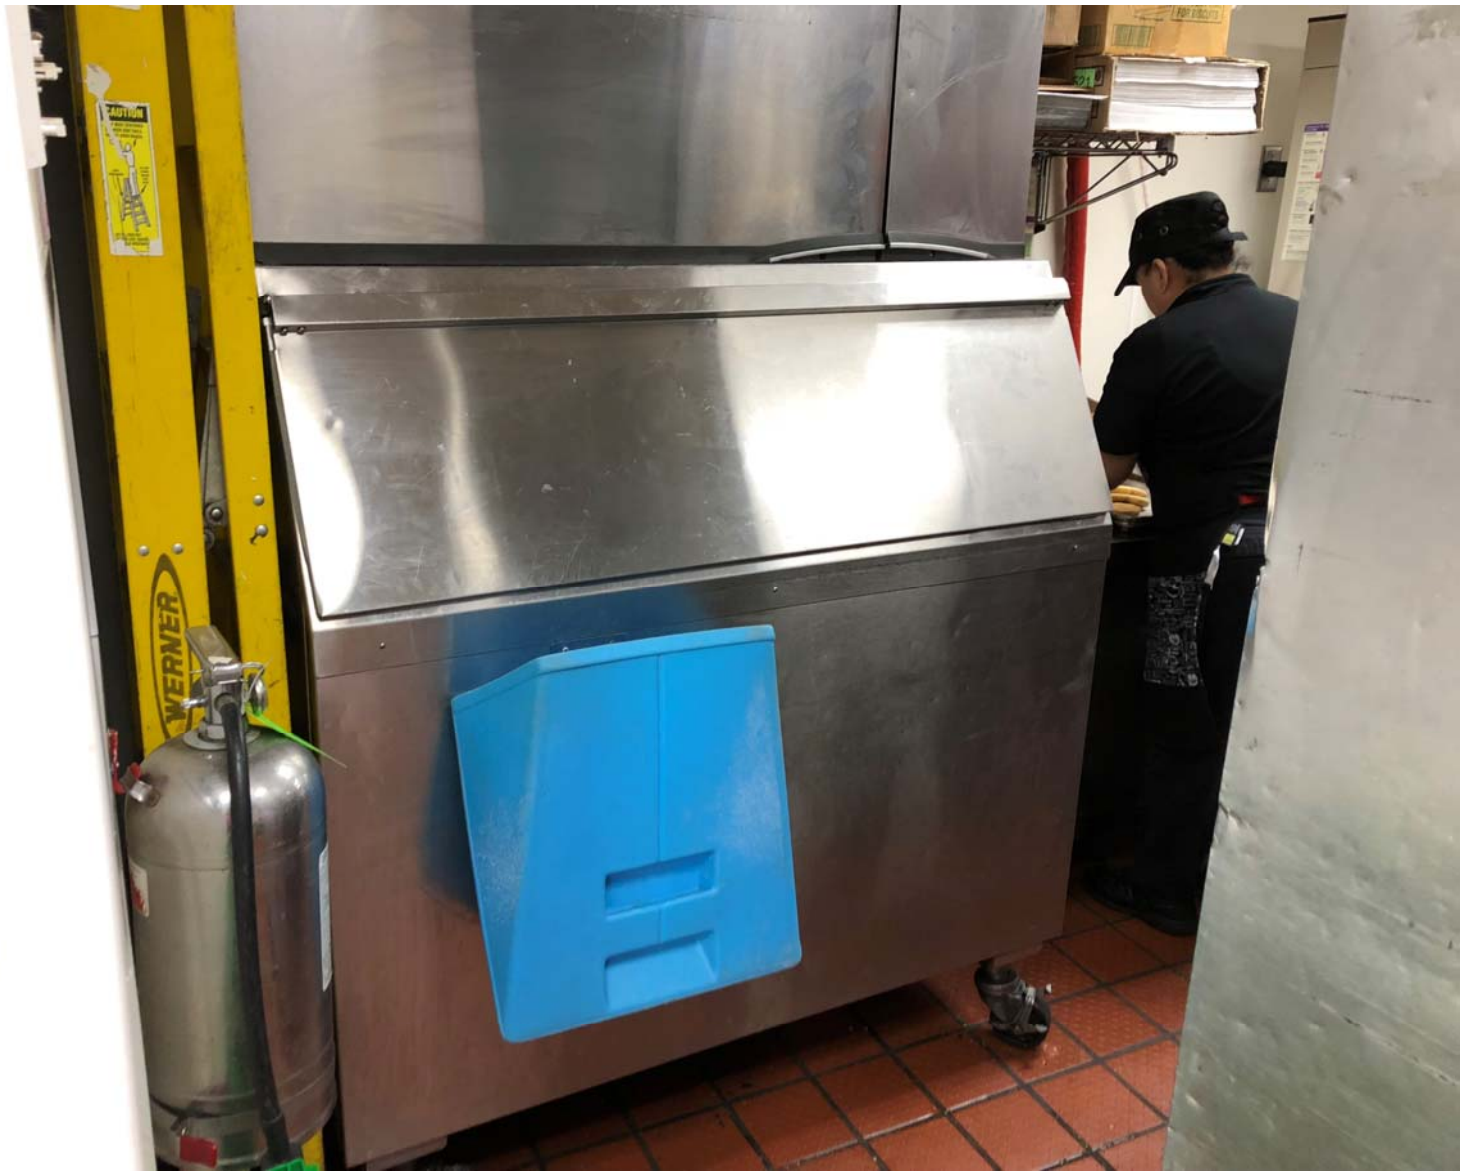
**Ice Machine**

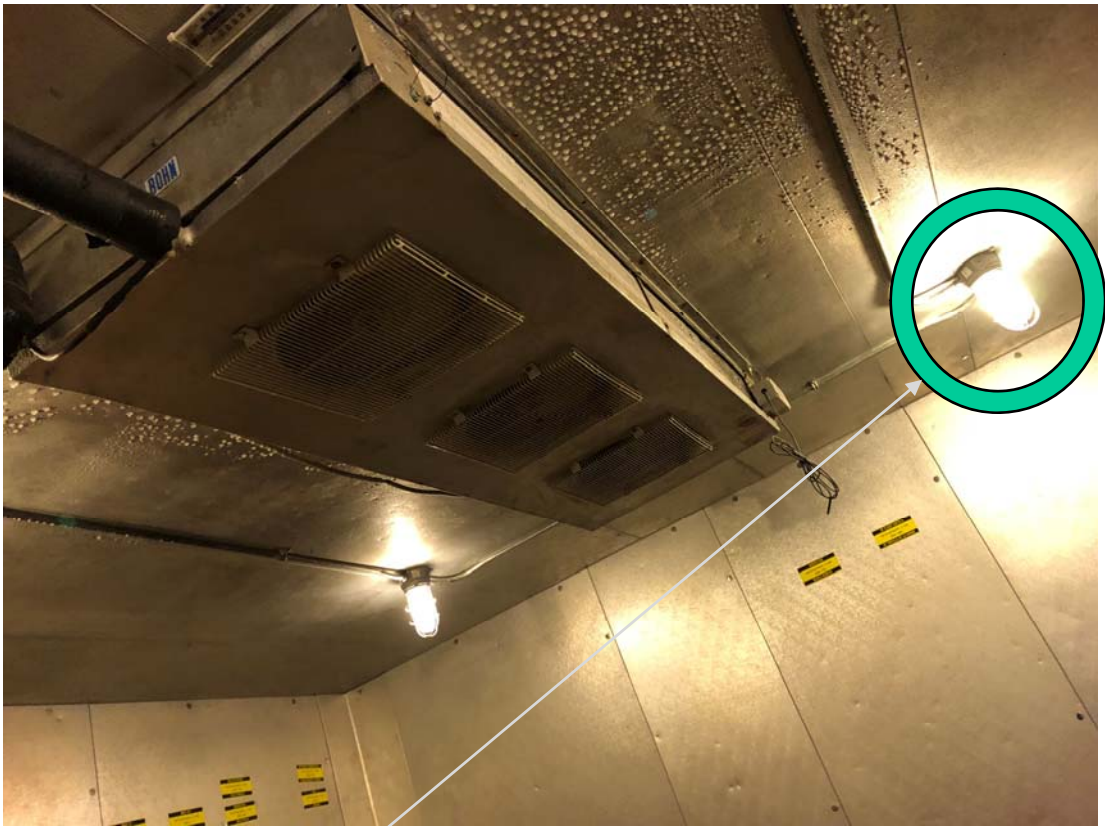
**CFL Bulbs**

Any mercury containing bulbs and PCB containing items should be carefully removed from the building and properly disposed of or recycled prior to demolition of the building.
