EXISTING PVC ROOF COVERS

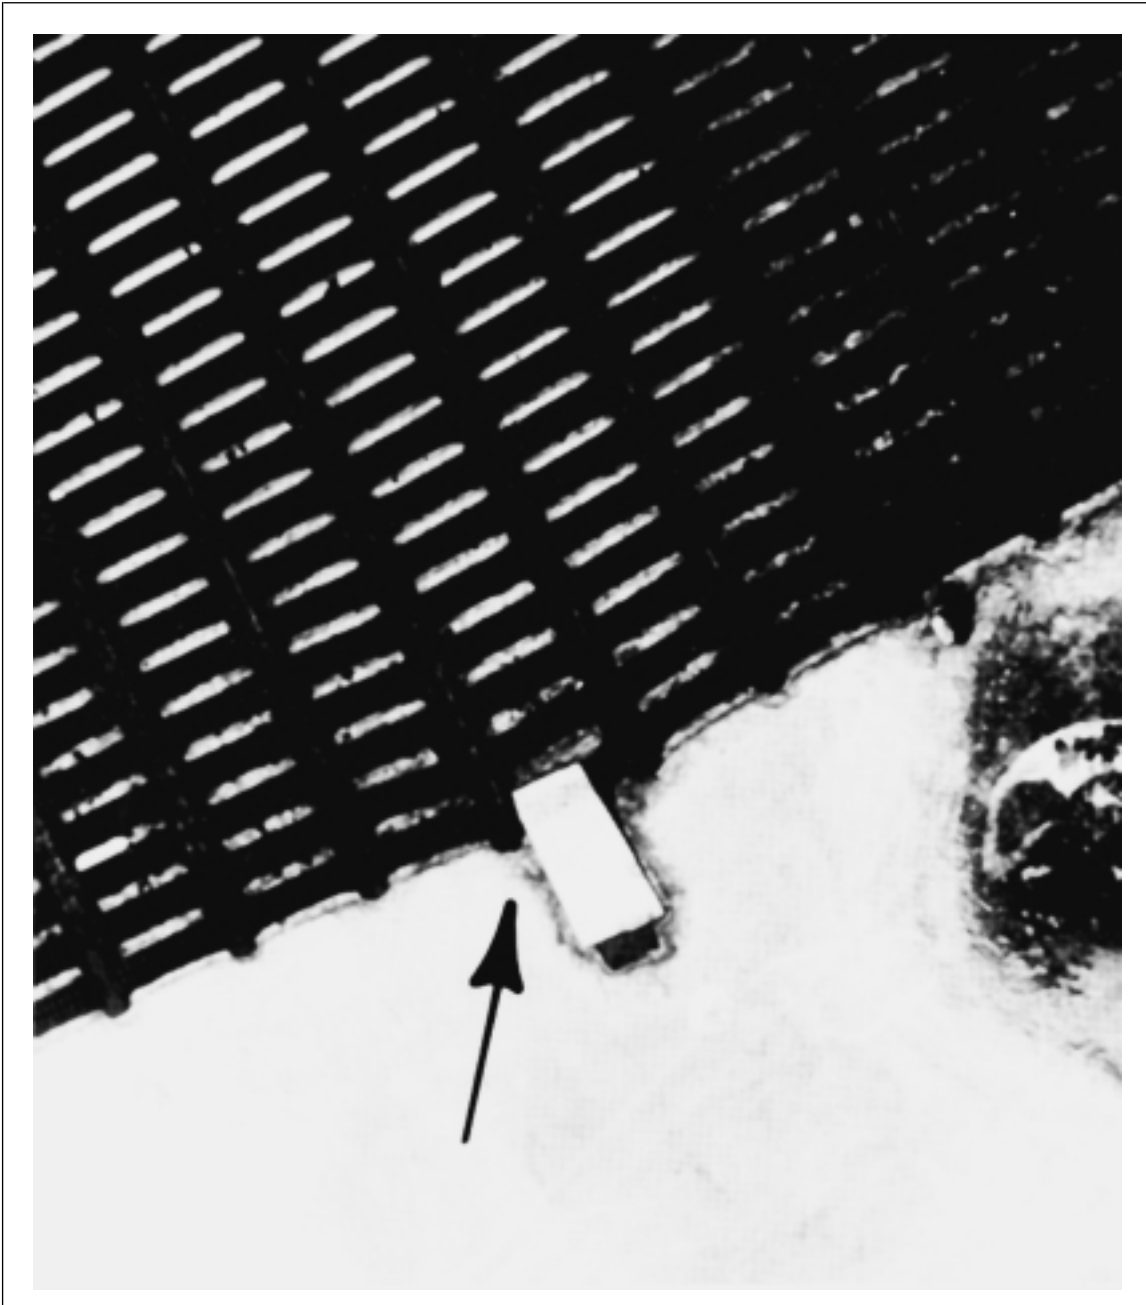
- Prior to shattering, the membrane may appear stretched at penetrations, walkway pads and flashings (Fig. 1). This is a result of membrane shrinkage.
- The membrane may be embrittled. That is, it may have lost some flexibility. This is usually best investigated at penetrations.
- The membrane may have developed small holes or slits.

Fig. 1. This rubber walkway pad had been secured to the PVC membrane with heat-welded tabs.

2.1.1.1 All unreinforced PVC roof membranes (whether ballasted or unballasted) that exhibit the warning signs noted below should be replaced with a Factory Mutual Research Approved (see Appendix A, for definition) roof cover system.
