Project Number: L0133-001-171

March 6, 2017

REFERENCE: **Brighton Recovery Campus, Building F (4953 S 900 E, SLC, UT)
Interior Demolition**

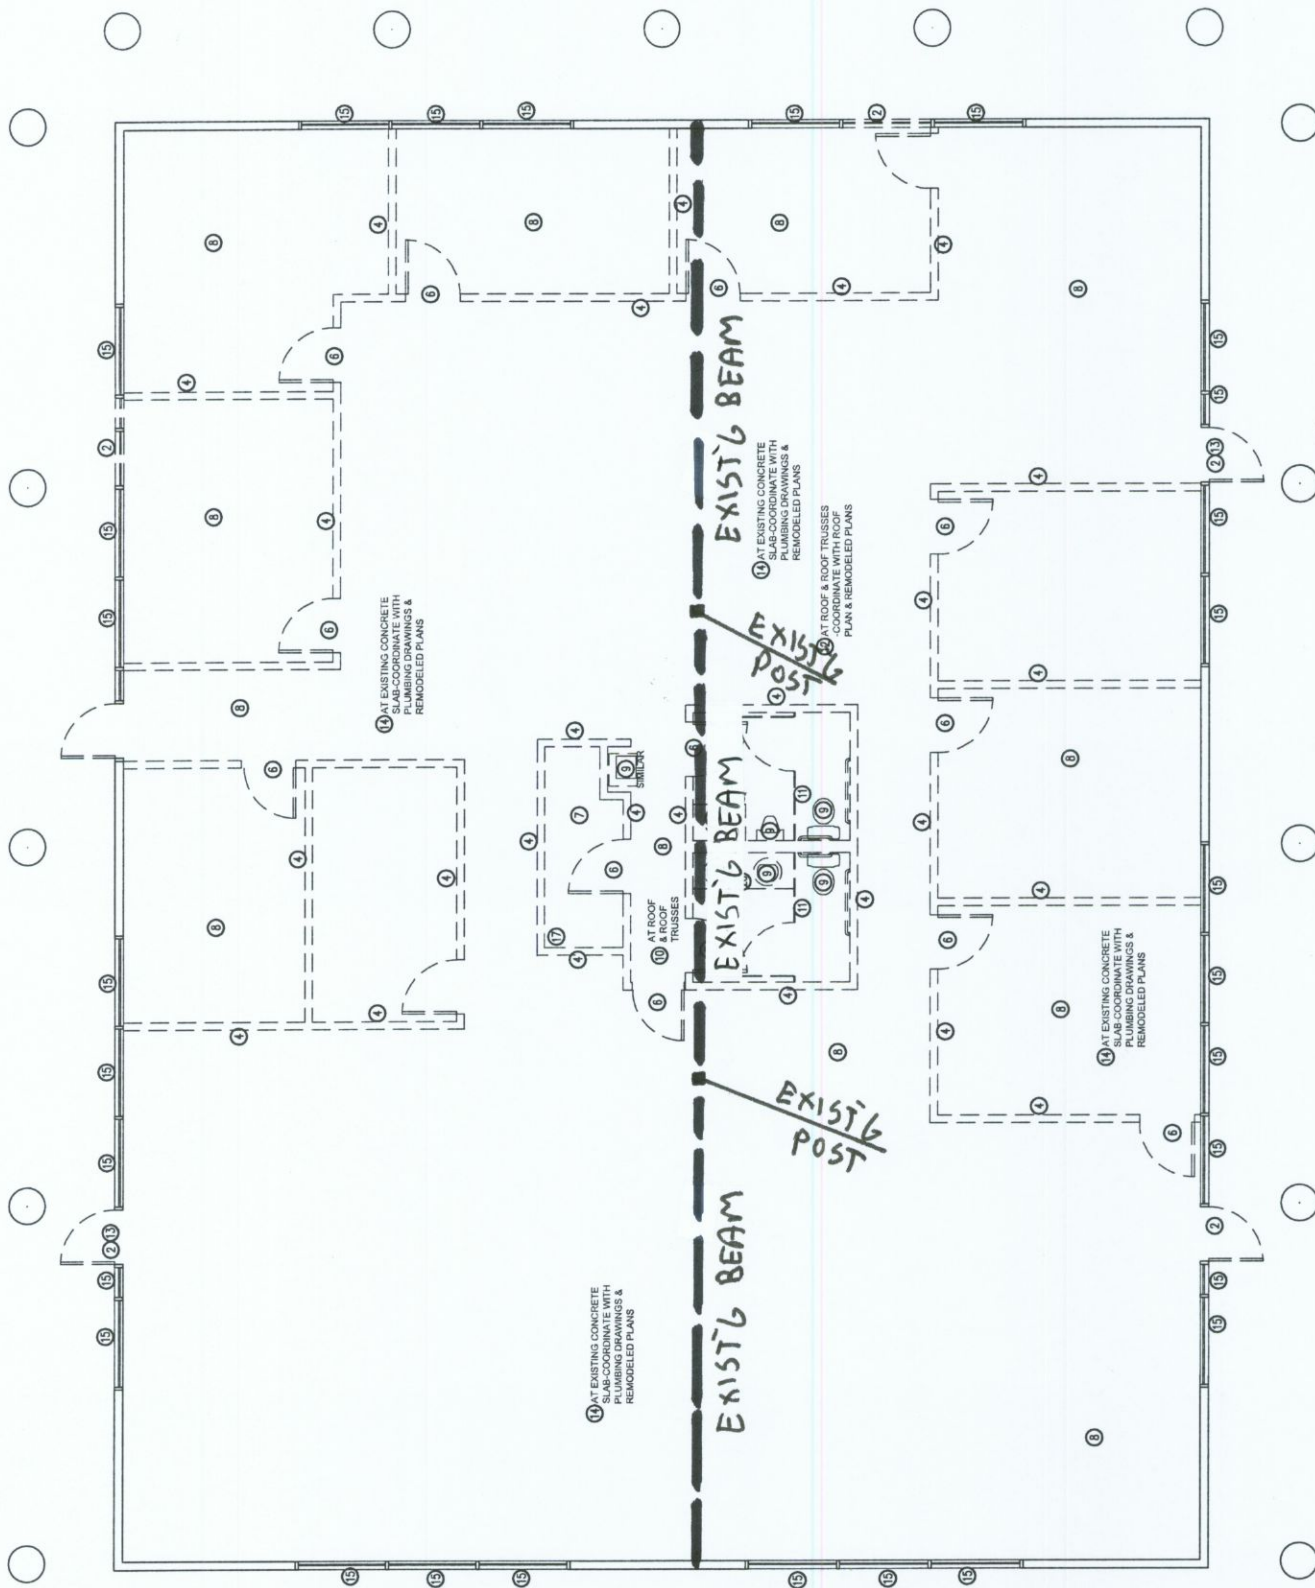
DEMOLITION PLAN
(FOR REFERENCE ONLY)

From our observation, the roof structure appeared to be manufactured wood roof trusses, bearing at the exterior perimeter walls and/or exterior overhang beams. In addition, there is an interior beam running the length of the building, supporting the roof trusses at or near their mid-span. See the attached "Demolition Plan," for approximate location of existing beams and posts. Interior partitions are non-bearing non-shear walls and can, therefore, be removed without adversely affecting the structure.
